## Rebuilding an alternate Lucas SLC2 switch

Faced with the fact I may never find an original switch in working order and wishing to proceed I have adapted a "switch casing" to an indicator switch.

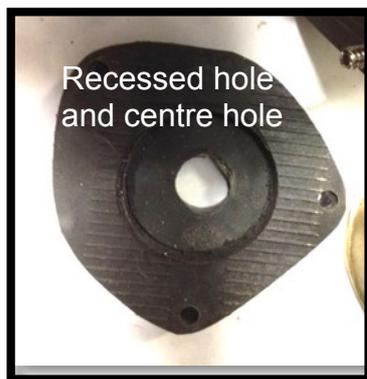
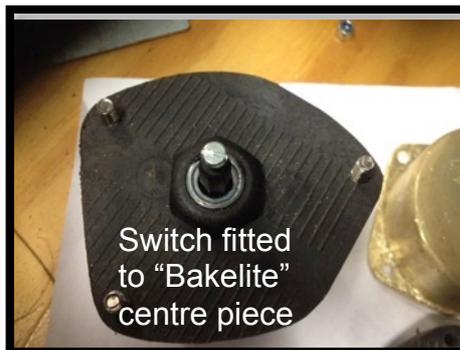
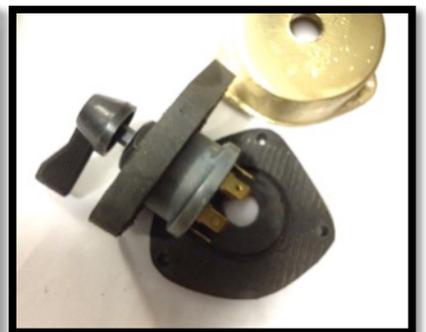
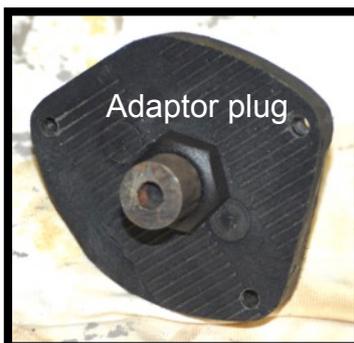
In the "Bakelite" piece I then used a woodworking hole drill to drill a recess for the indicator switch casing. See photos – this depends on the indicator fitting you are using.

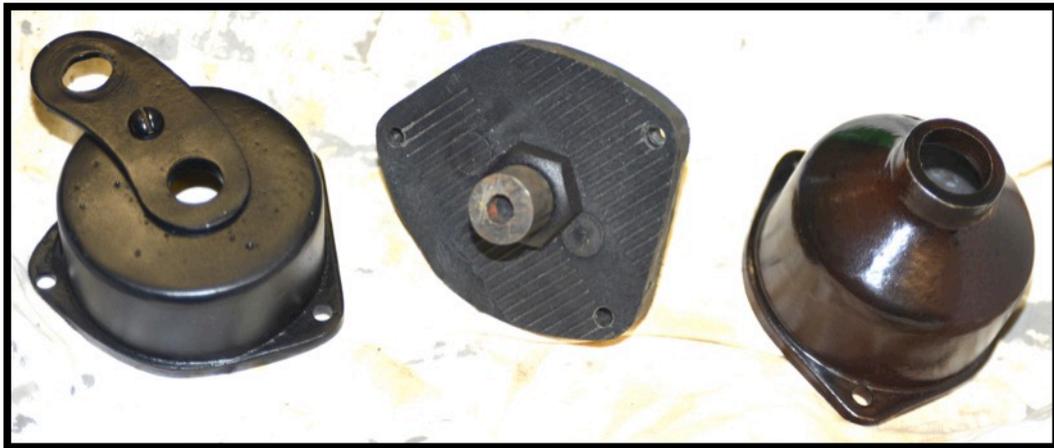
I then fashioned an adaptor plug to match the indicator arm and to receive the inner steering column. The inner steering column I made from 6mm stainless steel rod (I just happened to have a section). I heated and shaped one end to fit the adaptor plug.

At the steering wheel boss end this stainless steel inner shaft matches to the "indicator" arm provided by David Hardwick.

The pieces were then all painted ready for assembly. The top of the bottom of the SLC casing was originally "Bakelite" so this piece was painted with Mission Brown and then dusted with Black. This gives a pseudo Bakelite look. Finally, 2 or 3 coats of clear to protect the finish.

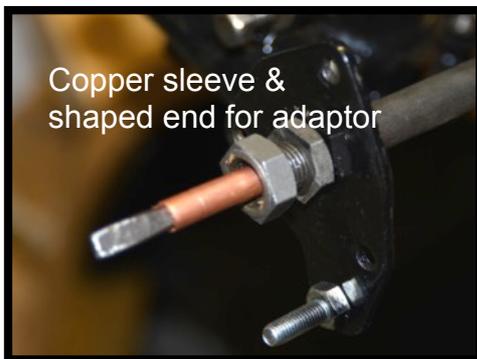
The stainless steel inner shaft was the given two copper sleeves (top and bottom) to ensure a neat fit inside the original inner column and easy movement of the indicator switch.

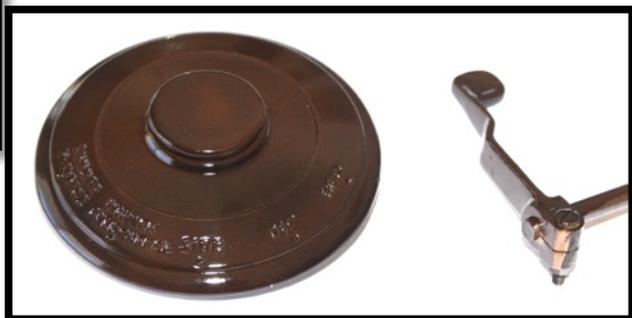
aluminium disk was attached to the underside to act as an upper stop for the stainless steel shaft.

The steering wheel boss was cleaned up and given the same paint treatment. An
